Rotating MachinesBulletin

SR0861X, SR0860X: Not dead out of the box!

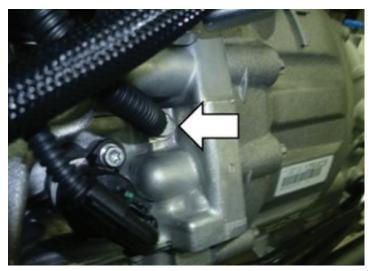
All of these conditions may be caused by a loose ground connection at point Z6000*4B on the engine block near the starter.

Note the location of the potentially loose cannon ground connection on the engine block near the starter.

To correct this condition, check and tighten the ground point Z6000*4B to 8 Nm. Then Clear all fault codes that might have been stored if the ground was found to be loose.
